Limited Asbestos & Lead-Based Paint Survey Report *Renovation, Commercial Property*

Site: 74 West 6th Street, Gilroy, California

S Tech Project: 20165

November 6, 2020

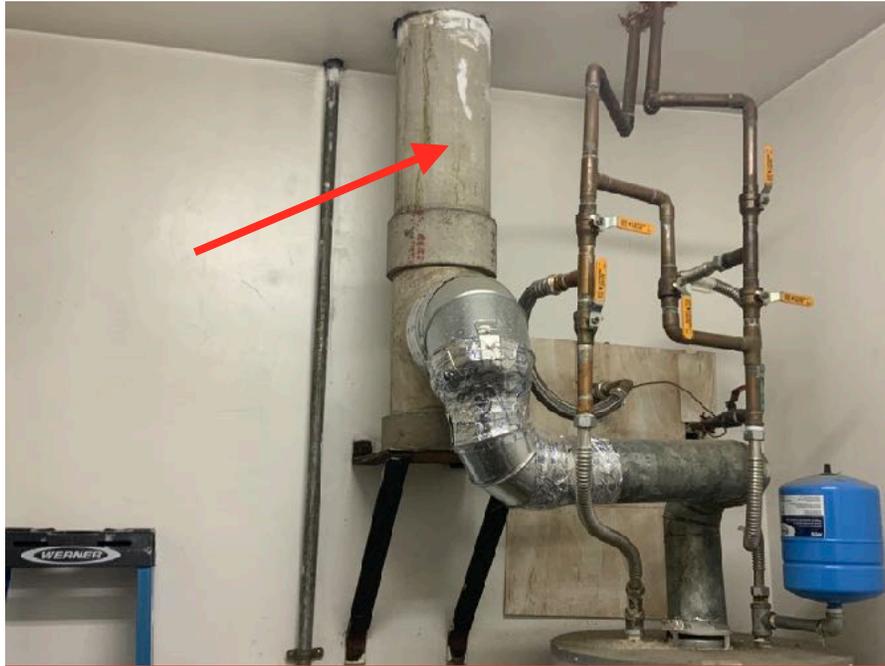
- * **In the utility room, there is an asbestos cement (Transite) flue pipe. Transite is classified as a Category II, Non-Friable Asbestos Containing Material (ACM) so long as it can be removed substantially intact. There is one pipe, approximately 12 lineal feet.**

Asbestos Summary Table				
Asbestos Material	Locations	Analytical Results	Classification	Approximate Quantity to be Removed
Transite Flue Pipe	Utility Room (Water Heater Flue)	Assumed	Category II Non-Friable, ACM	12 LF

Utility Room - Transite Flue Pipe (Water Heater Flue)

When conducting renovation or demolition, A State of California [C-22](#) Licensed Asbestos Abatement Contractor who is Division of Occupational Safety & Health (DOSH) registered, must be retained when disturbing materials containing greater than 0.1% asbestos ([Asbestos Containing Construction Material](#)). All work must be conducted in strict accordance with Cal-OSHA's asbestos standard, [8 CCR 1529](#) and the requirements of the Bay Area Air Quality Management District (BAAQMD) Rule 11. Waste must be disposed of in the correct landfill for the classification of asbestos being removed.

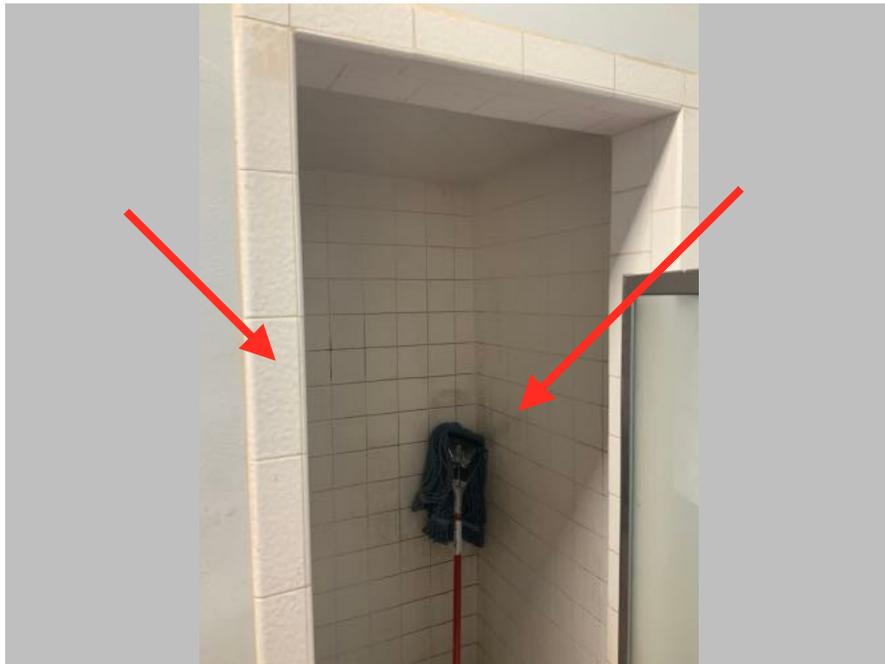
- * **Ceramic finishes in the men's restroom contain high lead content in the glazing. Uncontrolled demolition of ceramic finishes has the potential to release lead containing particulate, once the glaze is shattered.**

Lead (Pb) Summary Table				
Location	Component	Substrate	Analytical Results XRF: mg/cm²	Classification
Men's Restroom	Shower Wall & Ceiling Tile	Ceramic	>5.00	High Lead Content

Men's Restroom - Shower Tile With High Lead Content

Ceramic tile applications, where high lead content was identified, can release lead particulate during demolition activities, creating a lead exposure risk hazard for building employees and contract staff. Lead-safe work practices should be implemented during ceramic tile removal to ensure lead particulate is appropriately contained. HEPA vacuums should be used when conducting cleaning after demolition work. All wastes must be appropriately disposed of.
